HELICOPTER SECONDARY STRUCTURES  
RELIABILITY AND MAINTAINABILITY  
INVESTIGATION

Kenneth B. Krieger

United Aircraft Corporation

July 1974

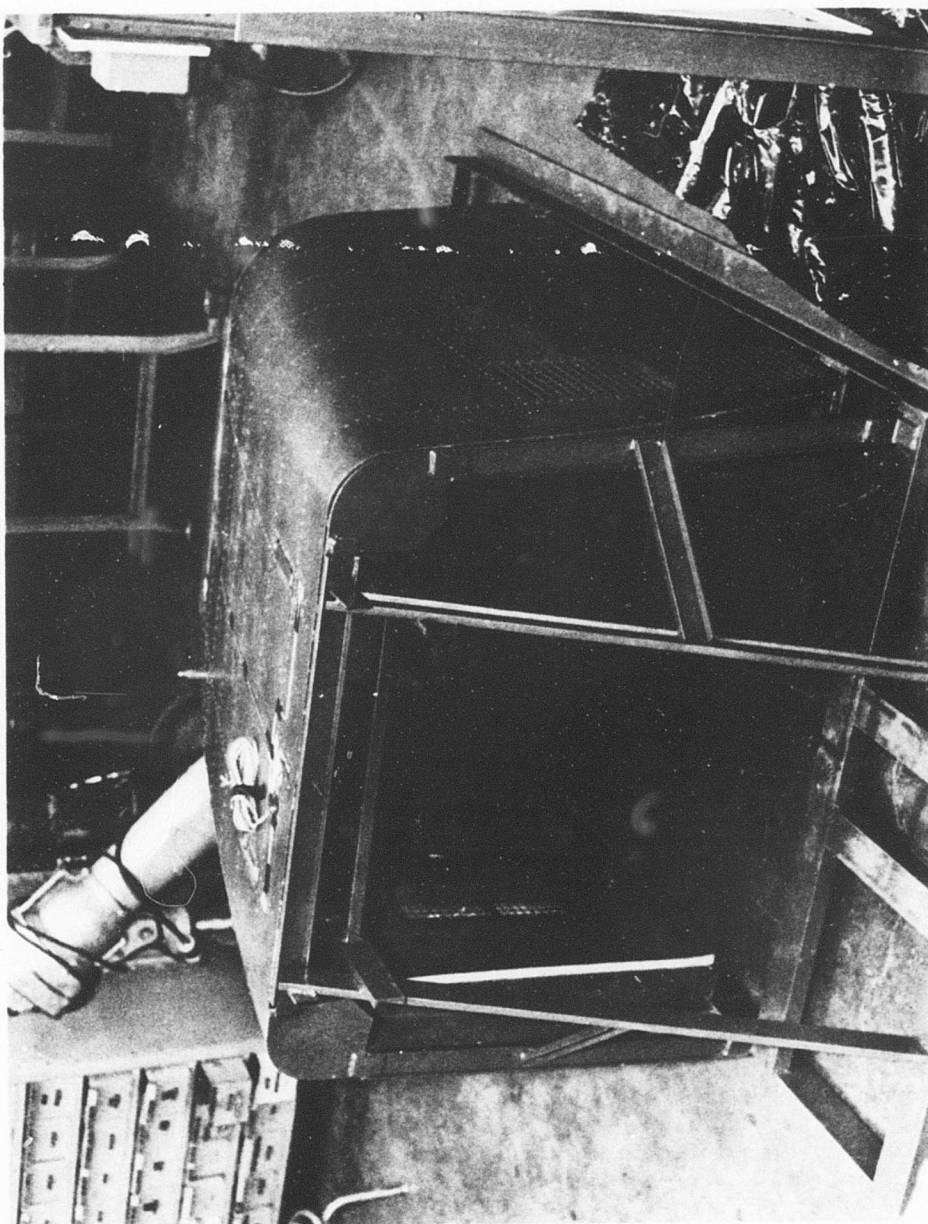
Figure 12. Main Rotor Pylon, Hinged Cover Assembly.

With the main rotor pylon hinged cover as originally designed (Figure 12), a slight amount of abuse was enough to cause a series of malfunctions and damage modes (Table XIV). All of the damage was caused by the first five abusive slams (open and close) on the hinged cover test schedule (Table IX). The hinged cover was then put onto the test fixture for the vibratory load (Figure 13). The vibration phase was halted after 90 hours running when it was found that the localized loading was cracking the hinged cover structure (Figures 14 and 15) which was not a realistic field mode.

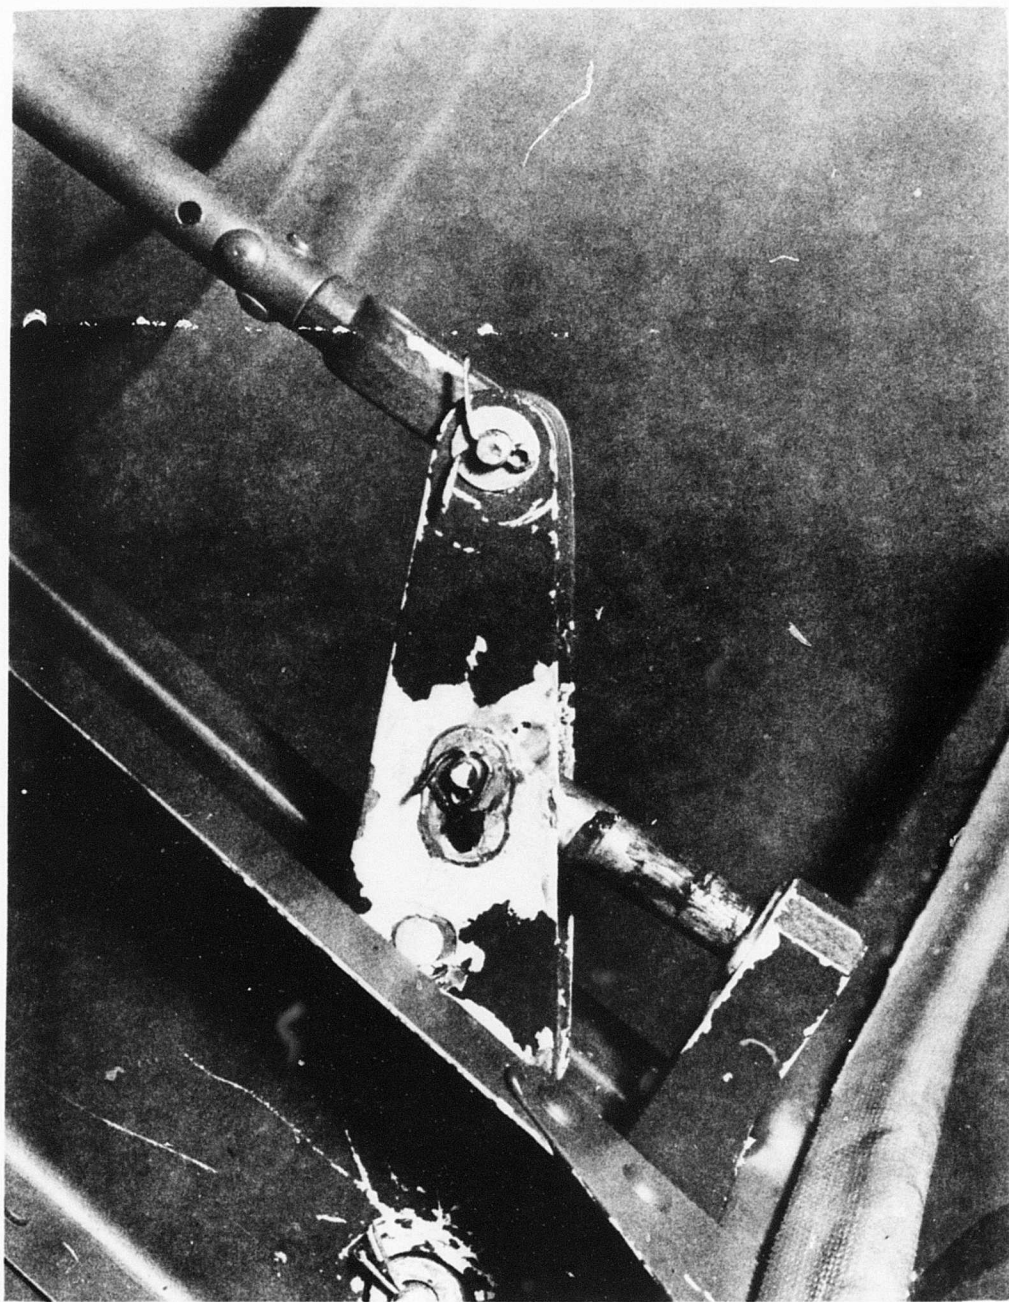
Figure 16. Main Rotor Pylon, Latch Assembly.

Major problem areas with the original design hinged cover included the latch assembly (Figure 16) which is susceptible to jamming. The fragility of the structure showed after one abusive slam (Figures 17 and 18), which pulled rivets and buckled stringers. The aft lower corner alignment pin mounting areas are easily bent (Figure 19). The forward lower corner alignment bushings interfere with the fiber glass shell (Figure 20).

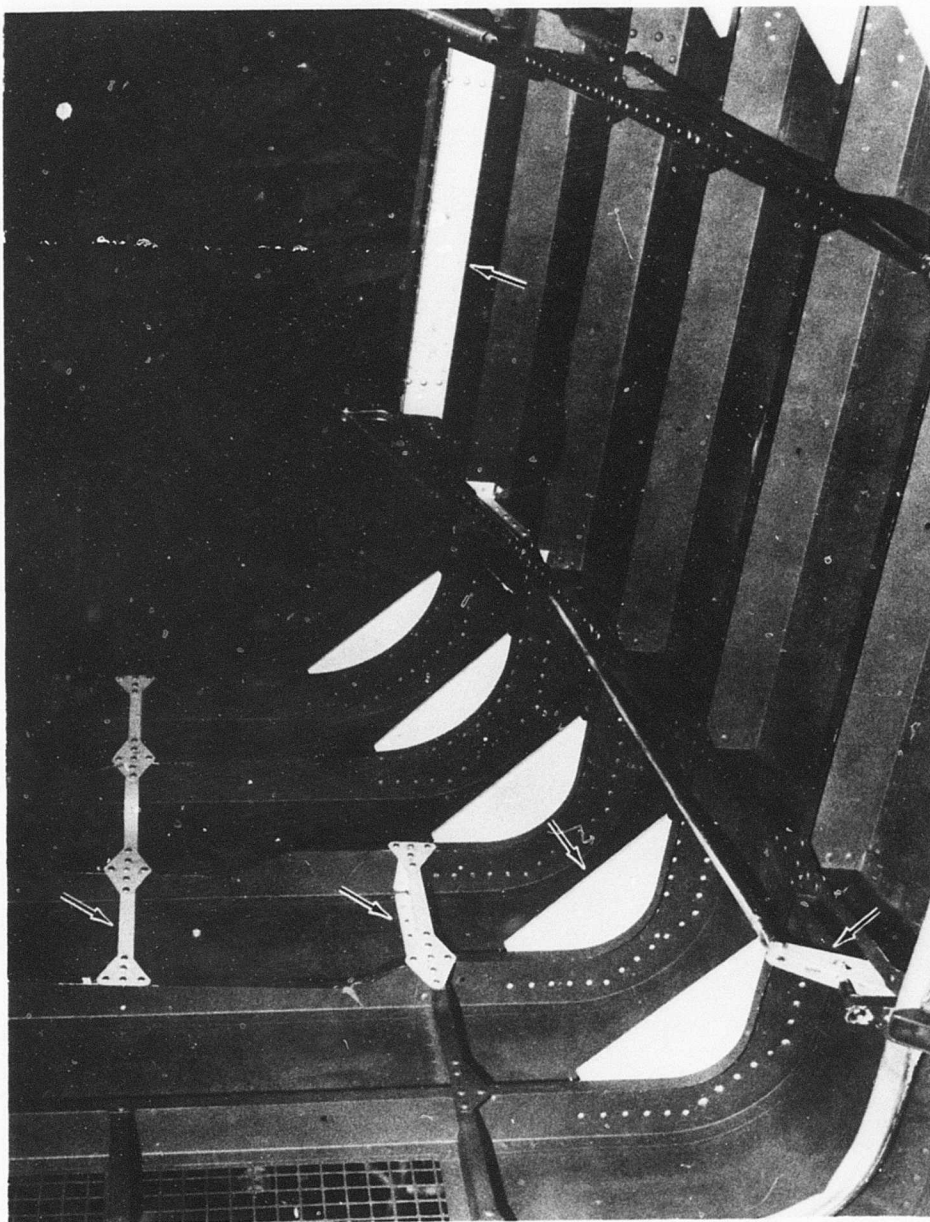
Figure 22. Main Rotor Pylon, Redesign.

The reworked cover (Figure 22) survived the abusive slams intact, except for the lower aft corner alignment pin mounts (Figure 23). This area on the test fixture has been found not to be typical of the aircraft, so the excessive damage incurred would not be a field damage mode (Figure 24).

The modified cover did show improved performance in resisting structural damage, misalignment, and latching difficulties. The modifications (Figure 22) include the light-colored parts shown: gussets, doublers, intercostals, and latch operating arms.

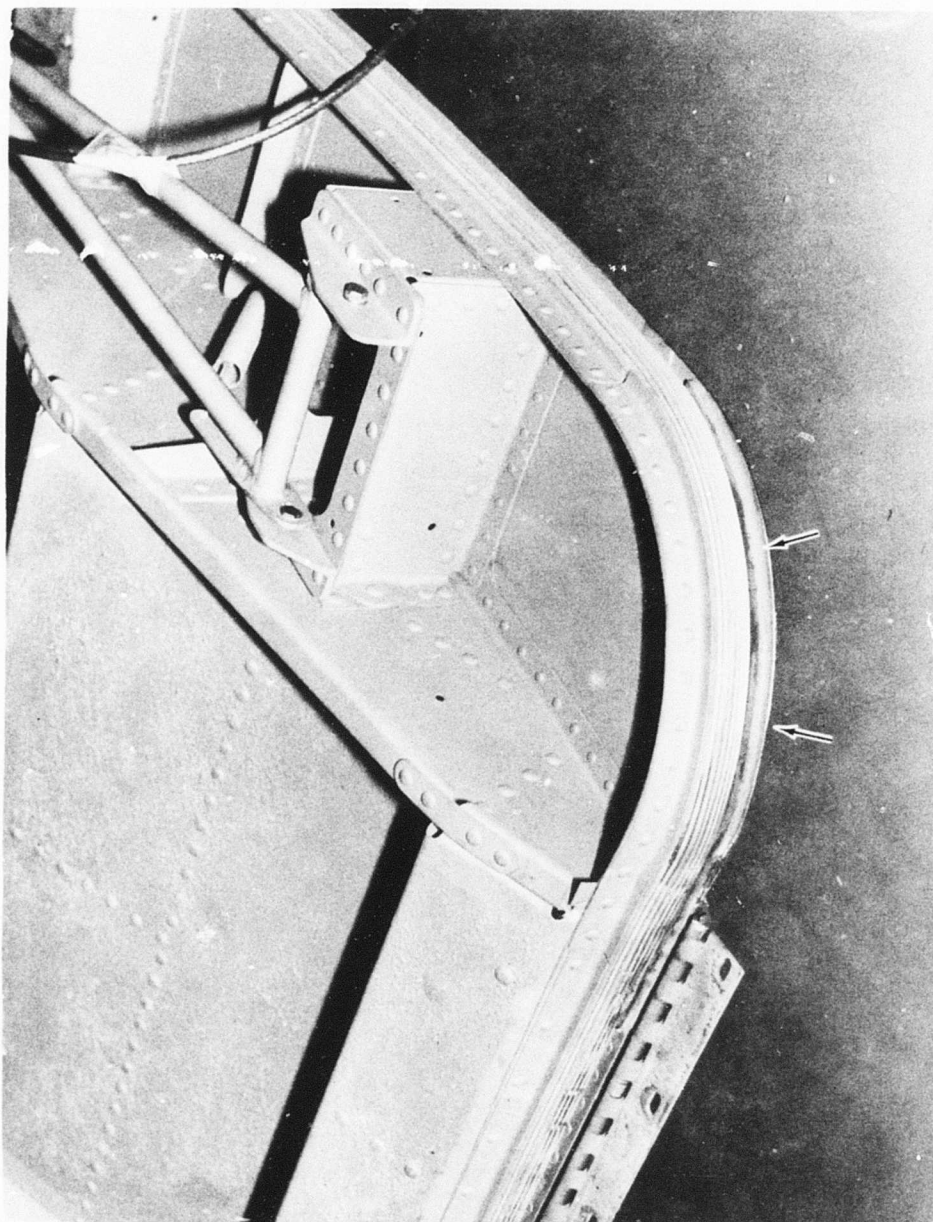
Figure 26. Lower Personnel Door, Seal, Original.

Testing of the lower personnel door (Figure 25) brought out the weaknesses of the original design (Table XV). The rubber seal (Figure 26) around the door inner edge prevented latching without excessive slamming. Initial installation of the door was also a problem, as it had to be shimmed at the hinge to align properly.

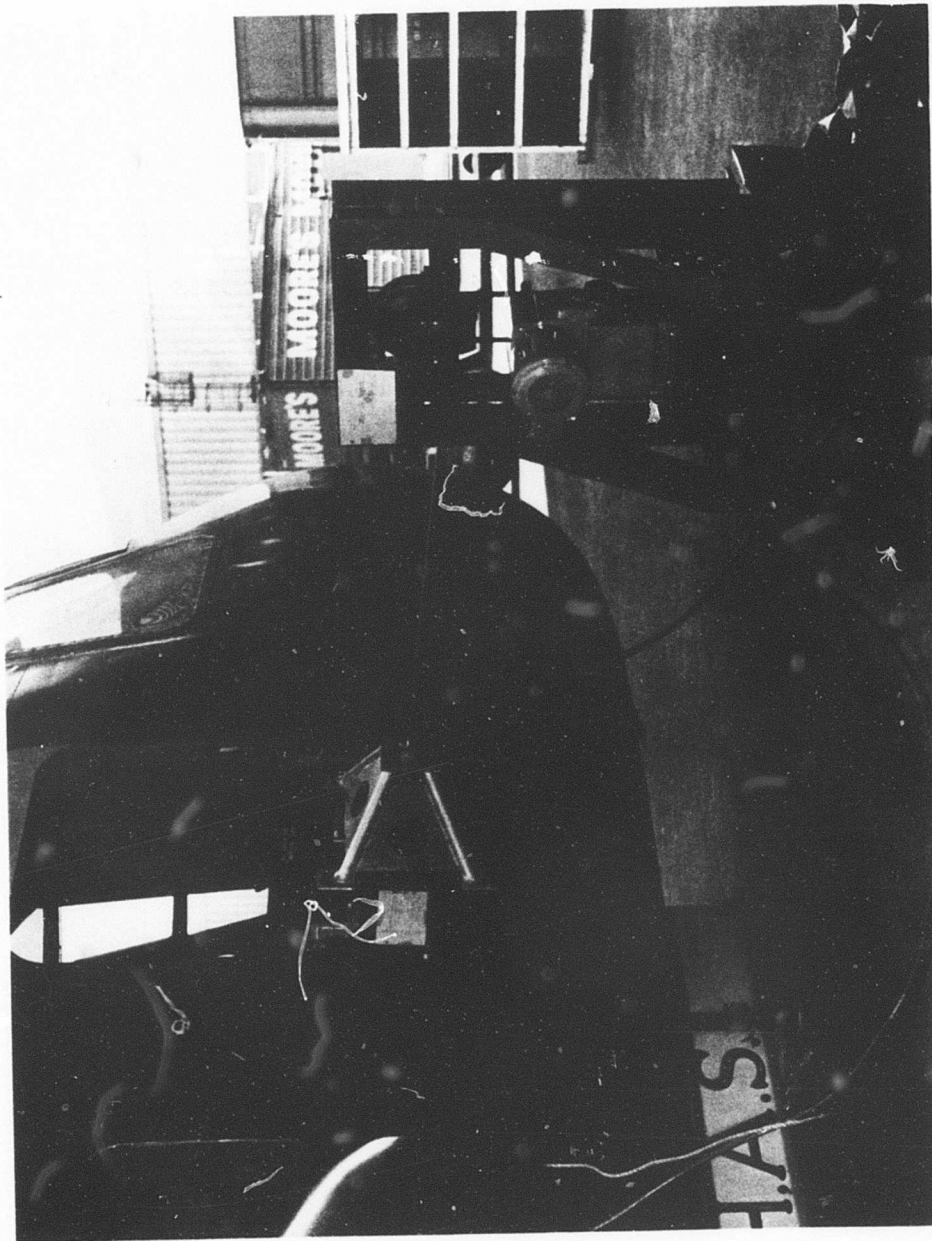
Figure 27. Lower Personnel Door, Vibratory Load Test Setup.

Unlike the other two test items, the vibratory loading on the door (Figure 27) resulted in fatigue cracks similar to field modes. The original design lower personnel door developed the cracks in the skin through the support

channels (Figures 28 and 29) at the latches in 175 hours of running. The redesigned door showed improvement. Although the same type of cracks appeared, they took longer (252 hours) and were smaller, not propagating as quickly.

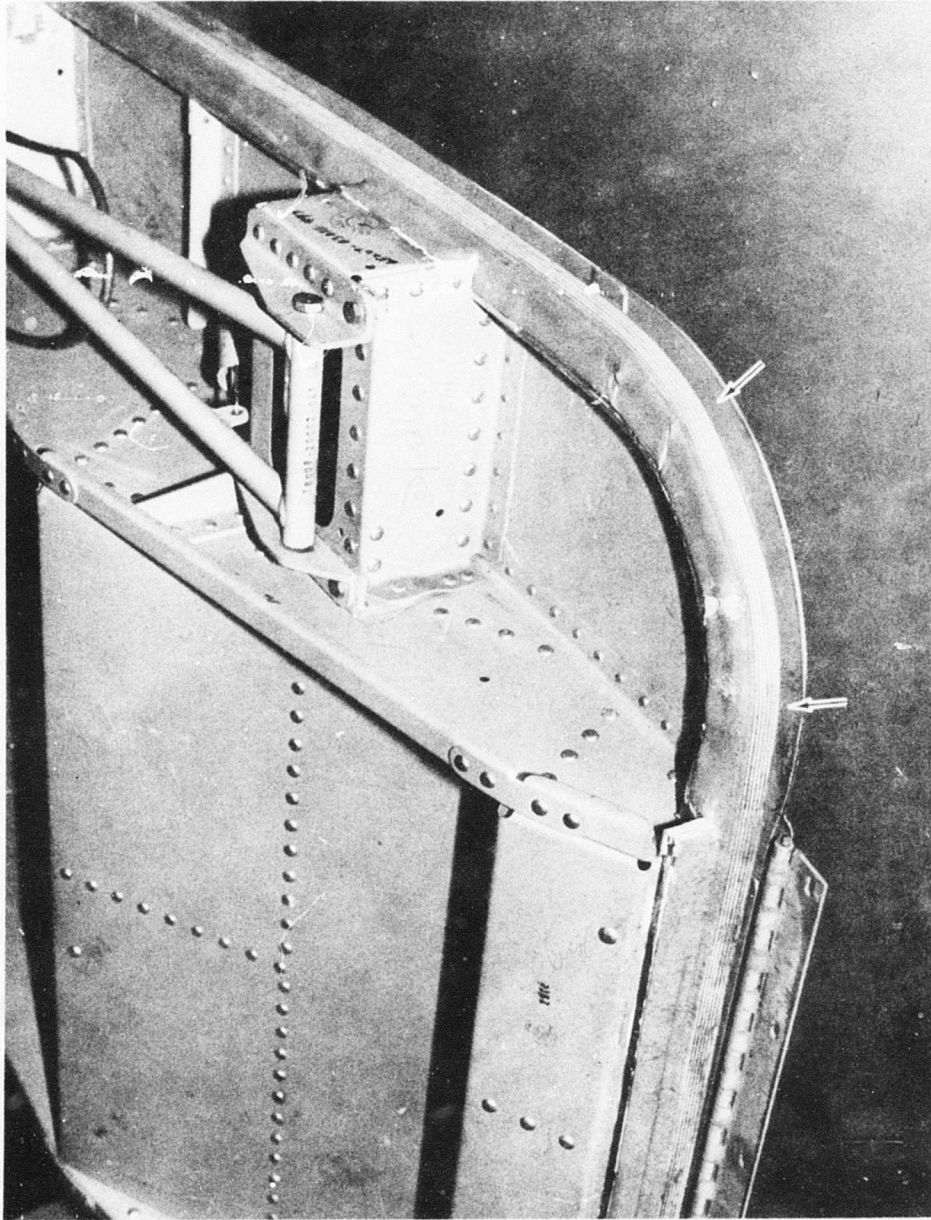
Figure 30. Lower Personnel Door, Redesign, Improved Seal.

Manual cycling showed that the redesigned door operated smoothly and easily without the binding seal problem (Figure 30).

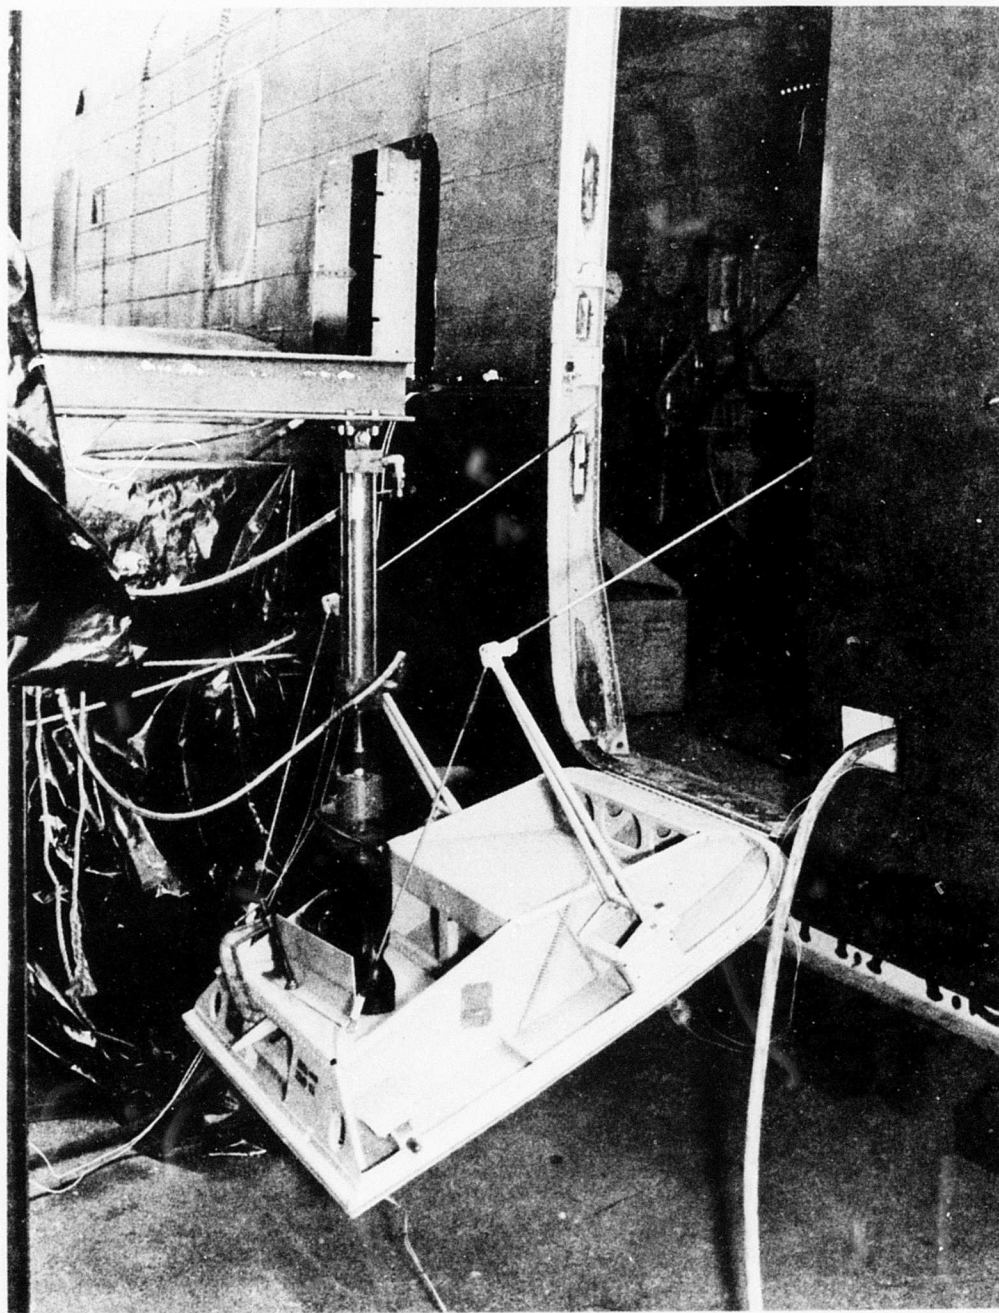
Figure 31. Lower Personnel Door, Boot Test.

Boot impacts (400 lb) on the lower step (Figure 31) produced a crack on one side between the original and redesigned doors (Figure 32). The boot impacts on the support cable (Figure 33) produced damage (bolt head pulling through the support) on the original door (Figure 34). The redesigned door sustained no damage on its strengthened support assembly (Figure 35).

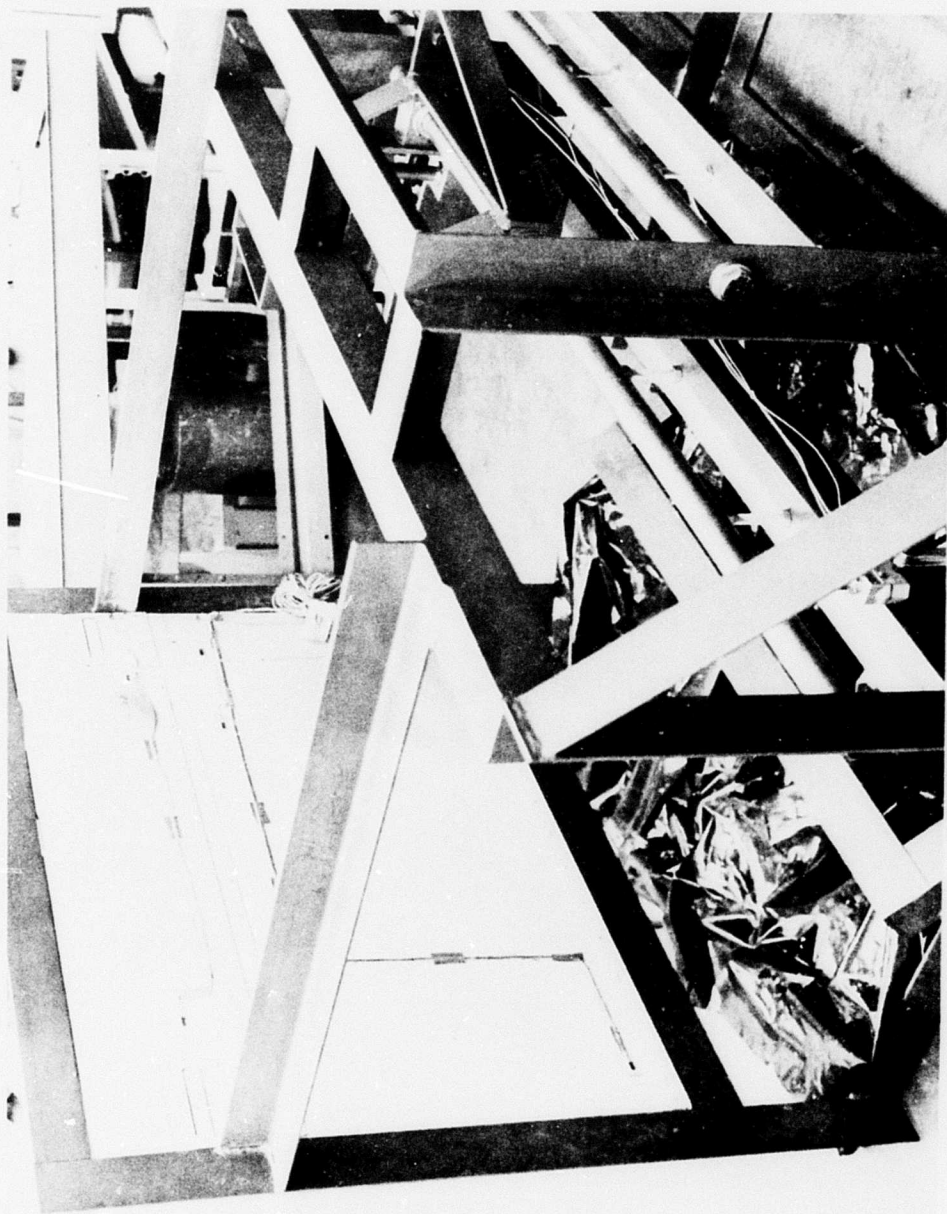
Figure 39. Work Platform Assembly.

The work platform assembly (Figure 39) has been failing in the field due to delamination of its fiber glass outside (weather) surface. Problems with the hinge and latches have also been reported (Table XVI).

TABLE XVI. REDESIGN OF WORK PLATFORM ASSEMBLY (P/N 65207-09004-041)		
Damage	Probable Cause	Corrective Action
(1) Cracking & Delamination of Fiber Glass	Unknown	Revised Work Platform from Aluminum, Balsa Core, Fiber Glass Laminated to Aluminum Honeycomb Structure
(2) Cracking Around Hinges and Latches	Unknown

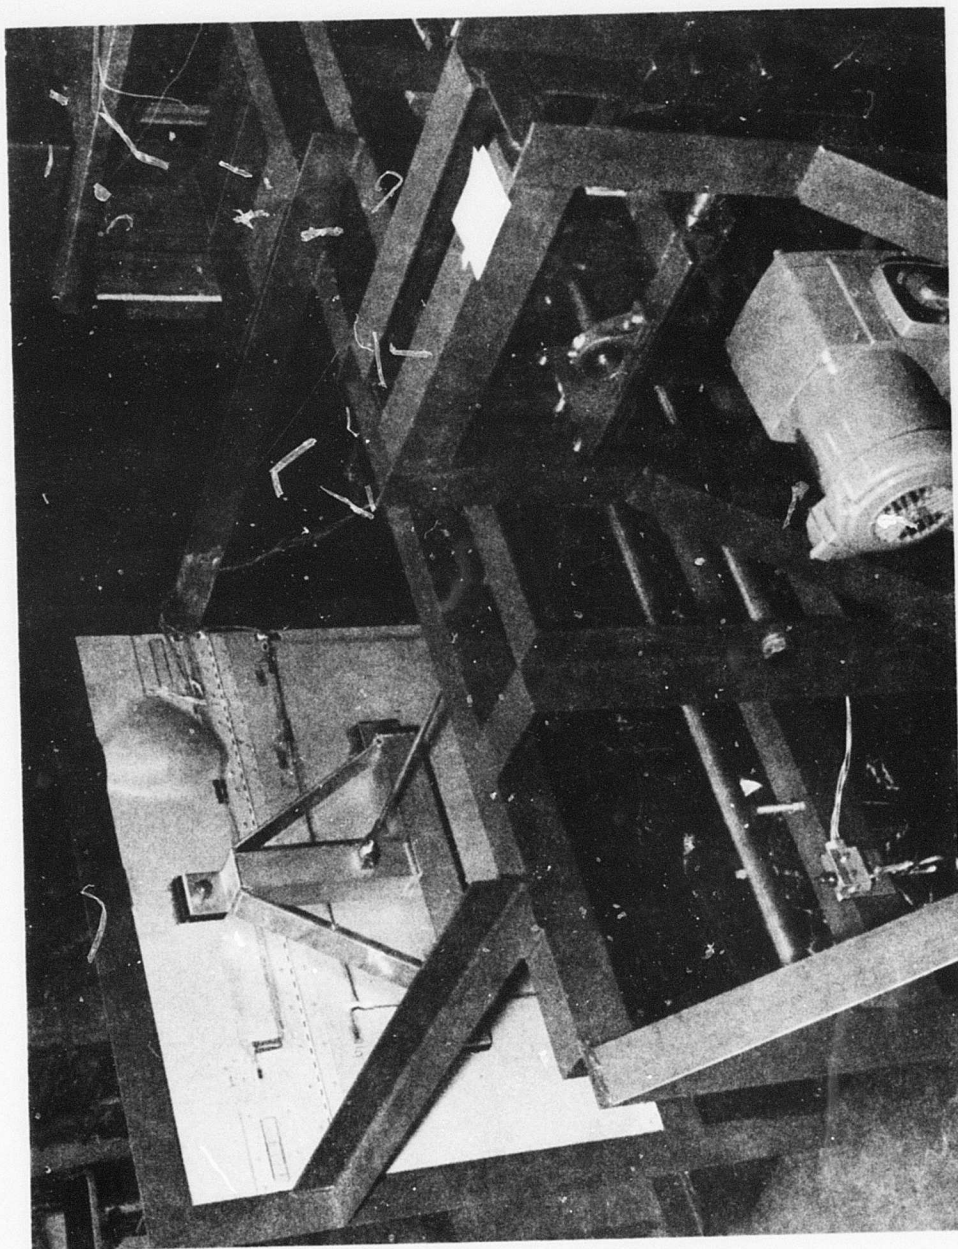
Figure 40. Work Platform Assembly, Vibratory Loading.

The vibratory loading produced no effects (Figure 40).

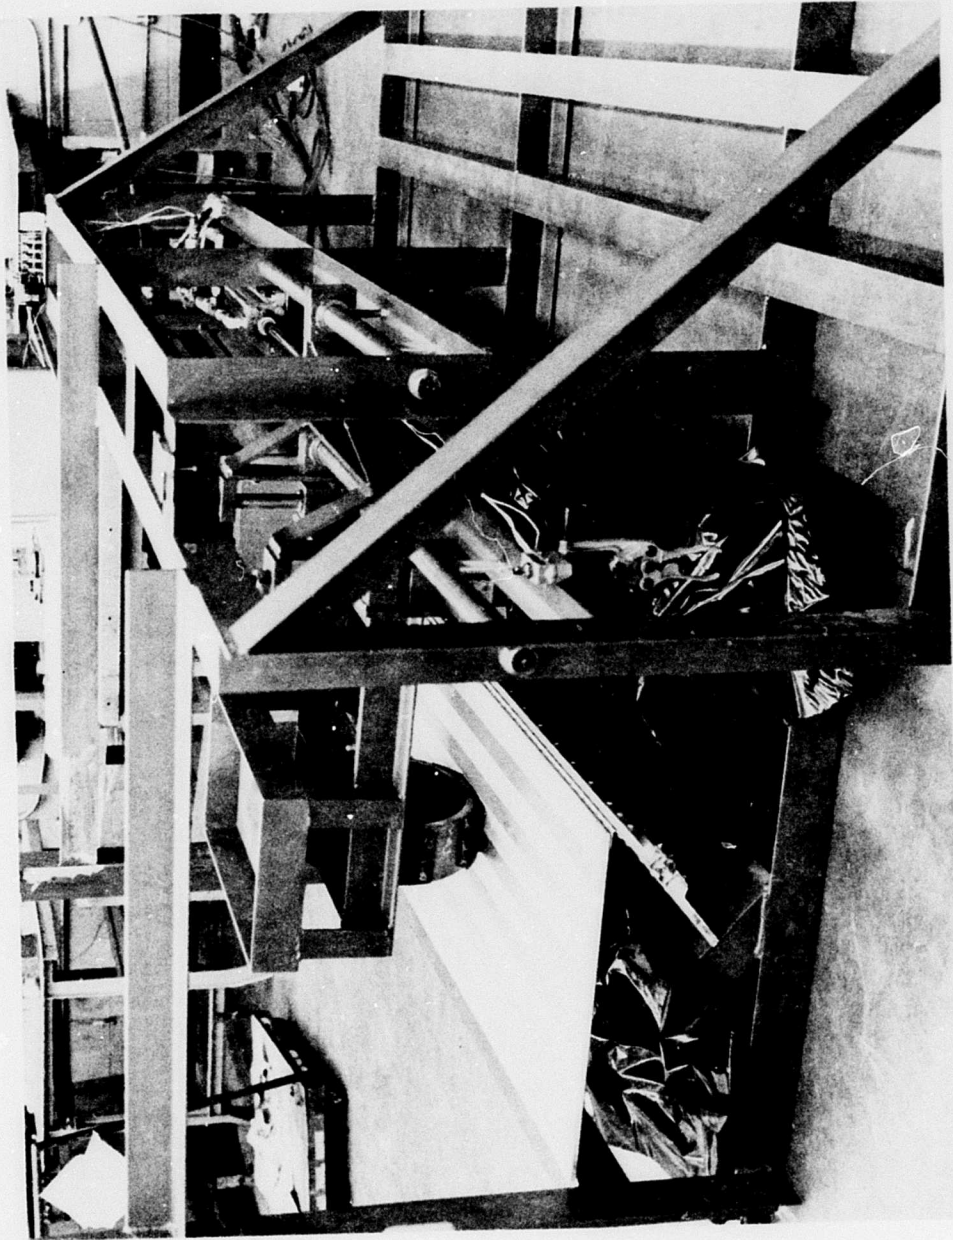
Figure 42. Work Platform Assembly, Roller Load.

The roller load (Figure 42) simulating men working on the platform was expected to produce the delamination field mode on the original design work platform assembly. However, this did not occur. Both the original and redesigned work platform assemblies lasted the full test without exhibiting the primary field mode of failure. The original did develop a field mode crack above the aft latch (Figure 43) after 300 hours of test when the roller load was increased to 400 pounds (2 men) from the 200-pound (1 man) loading. The crack after initial formation did not propagate further. This type of crack did not appear on the redesigned work platform assembly.
